Technical Bulletin M1190

Nel-Spot Tree Marking Gun Replacement Parts

Maintenance & Repair Instructions for Nel-Spot Tree Marking Guns

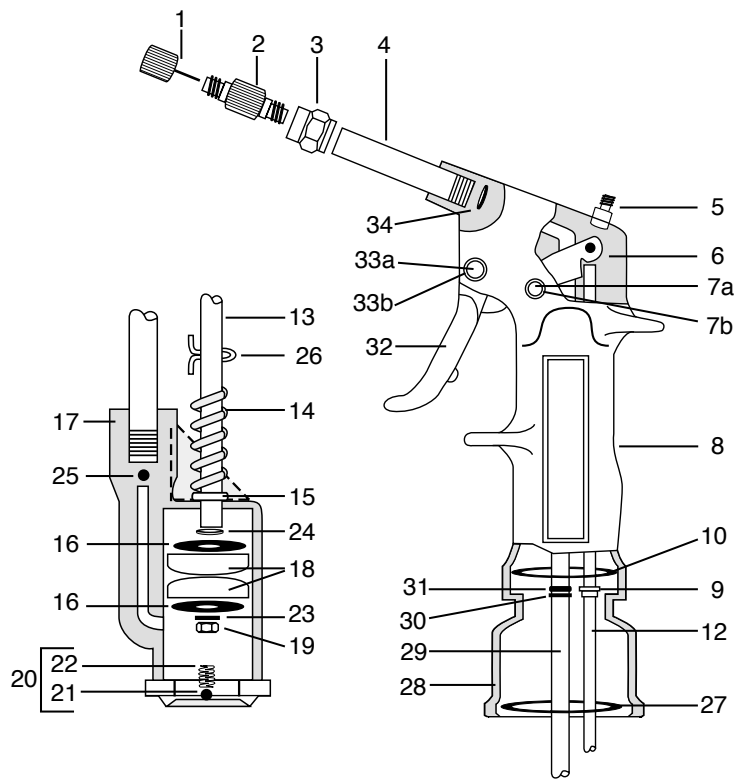
Nel-Spot Marking Gun Replacement Parts

Dia. No.	Stock No.	Description
1	55834	Nozzle Cap
2	55835	1 piece Reversible Nozzle, .021 (nickel finish)
2	55878	1 piece Reversible Nozzle, .029 (brass finish)
3	55836	Retaining Sleeve
4	55837	Extension Tube, 3"
5	55838	Nozzle Cap Holder
6	55839	Trigger Link
7a	55879	Trigger Link Pin
7b	55880	Retainer Ring (2 req.)
8	55841	Body
9	55842	Spacer Disc Assembly
10	55843	Gasket
12	55845	Upper Piston Rod
13	55846	Lower Piston Rod
14	55847	Spring
15	55848	Piston Rod Washer
16	55849	Washer
17	55850	Plastic Cylinder
18	55851	Cup Leather
19	55852	Hex Nut
20	55853	Intake Valve Assembly
21	55854	Intake Valve Steel Ball
22	55855	Intake Valve Spring
23	55730	Lock Washer
24	55857	Washer
25	55790	Steel Ball
26	55859	Cotter Pin
27	55860	Adapter Gasket
28	55861	Adapter
29	55862	Fluid Tube
30	55863	Retainer
31	55864	O-Ring
32	55865	Trigger
33a	55881	Trigger Pin
33b	55882	Snap Ring (2 req.)
34	55867	Gasket

1. If the trigger does not move or is suddenly very difficult to pull, it is likely the reversible nozzle is plugged. Reverse nozzle and pull trigger. This will usually unplug the nozzle. The cleaning wire on the Cap Assembly (No. 55834) can be used to dislodge dried paint or other tight foreign matter.

2. Inspect the Intake Valve (No. 55853) to see that the Steel Ball (No. 55790) can move freely and seats properly in hole at base of Intake Valve. A broken Intake Valve Spring (No. 55855) can be replaced after unscrewing Intake Valve from Cylinder. Insert the small end of the Spring against the Steel Ball and turn Spring until the large end is completely under the shoulder of the intake valve.

4. To remove or replace cup leathers, unscrew Intake Valve from Cylinder. Remove Cotter Pin (No. 55859) to release tension on the Spring (No. 55847). Grasp knurled portion of the Piston Rod and unscrew the Lower Piston Rod (No. 55846). The Lower Piston Rod complete with cup leathers can be removed from Cylinder. Note carefully the manner in which cup leathers and cup leather washers are assembled before removing parts from piston rod.

To reassemble, screw lower piston rod in place and replace spring and cotter pin to hold piston rod in place. Place one Cup Leather Washer (No. 55849) on Piston Rod. Insert one Cup Leather (No. 55851) with cup facing top of gun followed by the second cup leather with cup facing bottom of gun. Use extreme caution to avoid nicking or turning over the edges of cup leathers. The Nel-Spot Gun will not operate efficiently with damaged cup leathers. Replace remaining cup leather washer, the lockwasher (No. 55730) and the Hex Nut (No. 55852). Pull the Trigger to ensure the assembly moves freely and replace intake valve on cylinder.
5. If gun leaks an excessive amount of paint through handle, check the O-Ring (No. 55864) and Retainer (No. 55863) which should hold the Spacer Disc (No. 55842) tightly against the Gun

6. If gun leaks between Tube (No. 55837) and Gun Body, the Gasket (No. 55867) is damaged or missing. Do not attempt to stop leakage by over-tightening as this can strip the threads in the Gun Body.
7. If gun only functions when loosened from the paint can, then it most likely is the result of the Adapter Gasket (No. 55860)
