## Repair for Nel-Spot Tree Marking Guns

**No. 55833**  
Nel-Spot Tree Marking Gun

**No. 55909**  
Nel-Spot Dura-Built Tree Marking Gun

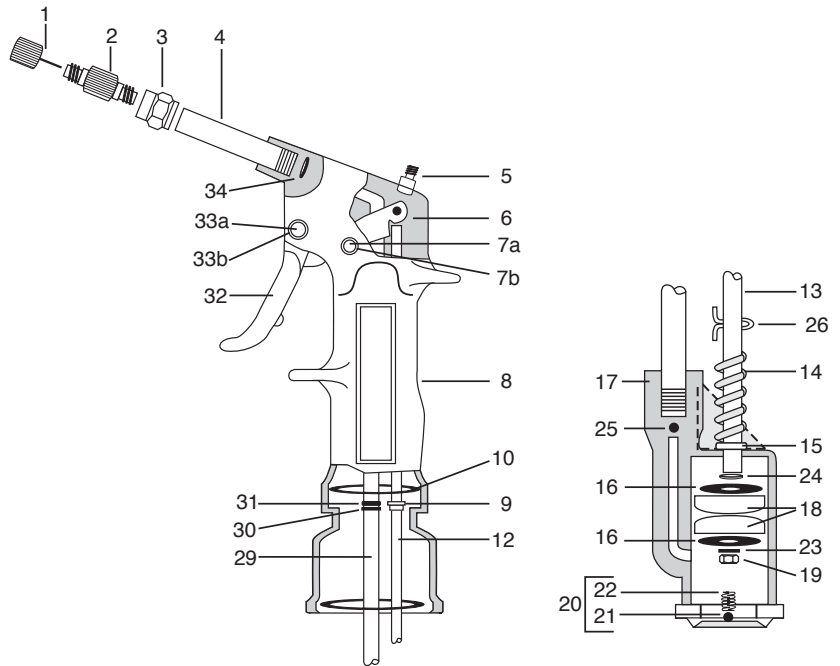
# Replacement Parts Diagram

55834	1	Nozzle Cap
55835	2	1 piece Reversible Nozzle, .021" (nickel finish)
55878	2	1 piece Reversible Nozzle, .029" (brass finish)
55836	3	Retaining Sleeve
55837	4	Extension Tube, 3"
55838	5	Nozzle Cap Holder
55839	6	Trigger Link
55879	7a	Trigger Link Pin
55880	7b	Retainer Ring (2 req.)
55903	9	Spacer Disc. Assembly
55860	10	Gasket
55906	12	Upper Piston Rod
55846	13	Lower Piston Rod
55847	14	Spring
55848	15	Piston Rod Washer
55849	16	Washer
55850	17	Cylinder
55851	18	Cup Leather
55852	19	Hex Nut
55853	20	Intake Valve Assembly
55854	21	Intake Valve Steel Ball
55855	22	Intake Valve Spring
55730	23	Lock Washer
55857	24	Washer
55790	25	Steel Ball
55859	26	Cotter Pin
55907	29	Fluid Tube
55863	30	Retainer
55864	31	O-Ring
55865	32	Trigger
55881	33a	Trigger Pin
55882	33b	Snap Ring (2 req.)
55867	34	Gasket

If your Nel-Spot Marking Gun does not function properly, check the following items in the order given (See Diagram on Page 2 for parts references.):

1. If the trigger does not move or is suddenly very difficult to pull, it is likely the reversible nozzle is plugged. Reverse the nozzle and pull trigger. This will usually unclog the nozzle. The cleaning wire on the Nozzle Cap Assembly (Ref. 1) can be used to dislodge dried paint or other tight foreign matter.

2. Inspect the Intake Valve (Ref. 20) to see that the Steel Ball (Ref. 21) can move freely and seats properly in hole at base of Intake Valve. A broken Intake Valve Spring (Ref. 22) can be replaced after unscrewing Intake Valve from Cylinder. Insert the small end of the Spring against the Steel Ball and turn Spring until the large end is completely under the shoulder of the intake valve.

4. To remove or replace cup leathers, unscrew Intake Valve from Cylinder. Remove Cotter Pin (Ref. 26) to release tension on the Spring (Ref. 14). Grasp knurled portion of the Piston Rod and unscrew the Lower Piston

Rod (Ref. 13). The Lower Piston Rod complete with cup leathers can be removed from Cylinder. Note carefully the manner in which cup leathers and cup leather washers are assembled before removing parts from piston rod.

To reassemble, screw lower piston rod in place and replace spring and cotter pin to hold piston rod in place. Place one Cup Leather Washer (Ref. 16) on Piston Rod. Insert one Cup Leather (Ref. 18) with cup facing top of gun followed by the second cup leather with cup facing bottom of gun. Use extreme caution to avoid nicking or turning over the edges of cup leathers. The Nel-Spot Gun will not operate efficiently with damaged cup leathers. Replace remaining cup leather washer, the Lock Washer (Ref. 23) and the Hex Nut (Ref. 19). Pull the Trigger to ensure the assembly moves freely and replace intake valve on cylinder.

5. If gun leaks an excessive amount of paint through handle, check the O-Ring (Ref. 31) and Retainer (Ref. 30) which should hold the Spacer Disc (Ref. 9) tightly against the Gun Body. Be sure there is a Gasket (Ref. 10) between the Adapter (Ref. 28) and the Gun Body and that the Adapter is tightened.  
To replace O-Ring, unscrew Lower Piston Rod as described above, but do not remove cup leather from Cylinder if not necessary to soften or replace them. Unscrew Cylinder (Ref. 17) from Fluid Tube (Ref. 29). Slide retainer off Fluid Tube, replace O-Ring and Retainer and reassemble Cylinder and Piston Rod.

6. If gun leaks between Tube (Ref. 4) and Gun Body, the Gasket (Ref. 34) is damaged or missing. Do not attempt to stop leakage by over-tightening as this can strip the threads in the Gun Body.

7. If gun only functions when loosened from the paint can, then it most likely is the result of the Adapter Gasket (Ref. 27) being excessively worn or missing. This causes the Intake Valve Assembly (Ref. 20) to seal itself against the bottom of the can. Replace or add a new Adapter Gasket to alleviate the problem.
